### Swift Response to Underground Line Break Reduces Facility Downtime

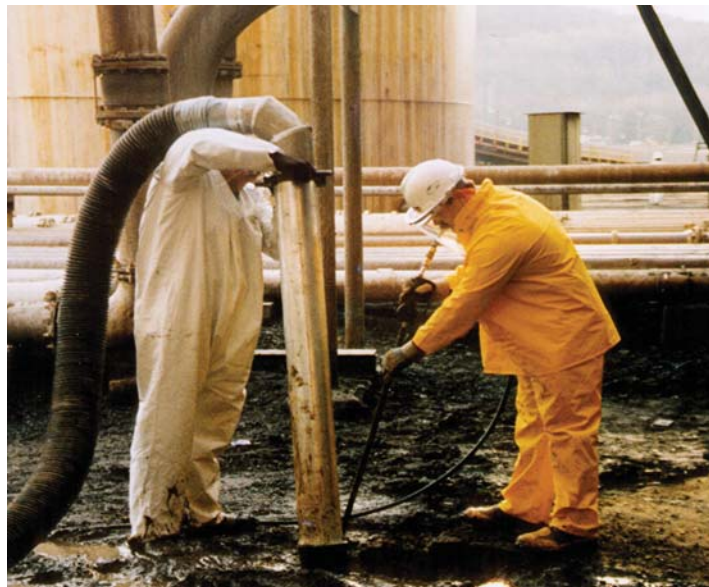
*MPW's Hydro Excavation process provides a safer, non-destructive digging method to traditional means of exposing underground infrastructure. Backhoes, shovels and bobcats run the risk of damaging underground infrastructure and increasing the safety and financial risks associated with a utility strike.*

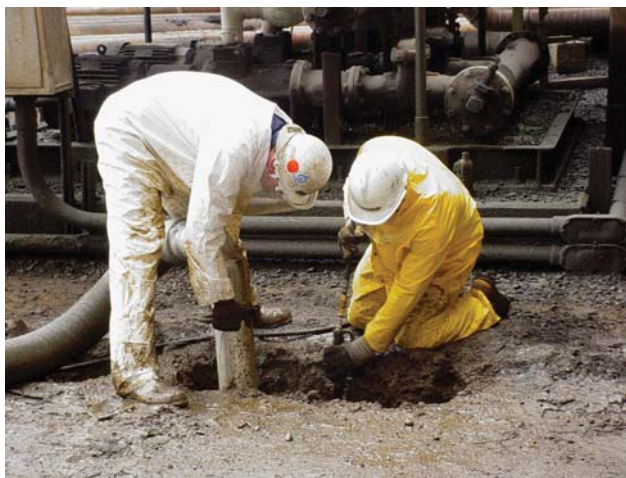
*Minimal labor support is required to perform MPW's Hydro Excavation services due to the propriety equipment designed by MPW's in-house engineering and fabrication department.*

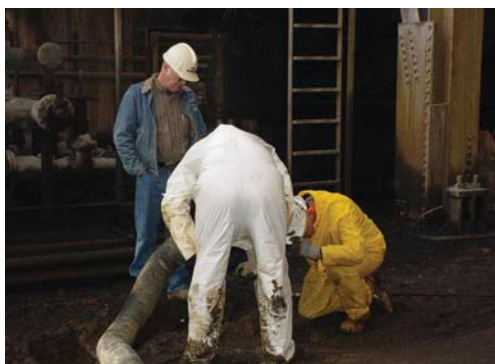
The line break was discovered approximately 4 ft. from where plant personnel had anticipated that it had occurred. The use of a backhoe or digging equipment to locate the break could have been catastrophic. The Hydro Excavation method proved faster, safer and far more efficient than conventional excavation methods. MPW technicians excavated a 3 ft. x 5 ft. x 6 ft. hole in extremely hard soil conditions with surgical precision. MPW avoided overhead obstructions and any damage to the adjacent process and utility lines, which requires costly repairs. Plant personnel inspected the dig and were able to immediately repair the break. The emergency dig exceeded expectations without injury to personnel. Due to MPW's swift response, the Hydro Excavation method proved to minimize safety and financial risks as well as reduce the anticipated downtime.

*Plant personnel and MPW technicians inspect the unearthed broken process line following Hydro Excavation, verifying no visual damage to adjacent utility lines.*

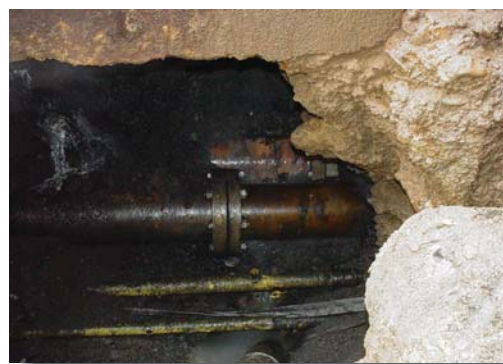
effectively uncover the leak without disturbing the underground lines. The water/soil mixture was carefully loosened and immediately removed with a high capacity vacuum truck. The excavated soil slurry was vacuumed and contained within the holding box of the vacuum truck and dumped on-site, minimizing restoration costs. The non-destructive process was repeated with surgical precision exposing critical process and utility lines. The fractured pipe was located 6 feet beneath the substation concrete platform.

*View: Underground line break exposed beneath the substation concrete platform. The removal of soil slurry made it possible for plant personnel to immediately repair the broken line, further reducing downtime.*
