### MPW's Jacket Water Cleaning Reveals Hidden Threat

#### Problem

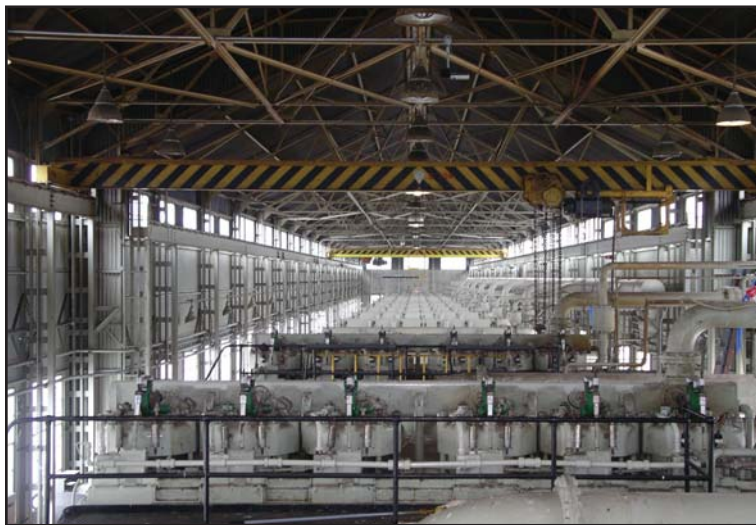
*MPW technical support delivers over 125 years combined operations and applications expertise to effectively clean glycol cooling loops and jacket water systems. MPW manages all aspects of draining, filtration, flushing and refilling. Chemical and mechanical cleaning methods ensure that unit life expectancy is increased, heat transfer is improved and flow is restored.*

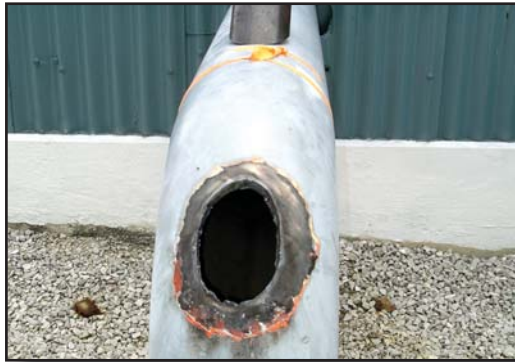
*Weld-a-Lets were installed to gain access to clean underground low points. MPW pumped Norkool™ cleaners, degreasers and inhibitors through the process pipelines to remove heavy build-up of solids and contaminants that accumulate, as there is little fluid motion to keep them suspended.*

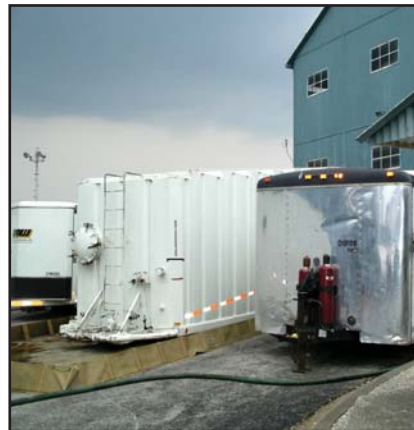
*Solubility studies are conducted utilizing various chemical formulations. MPW's fleet of mobile jobsite laboratories are built in-house to provide rapid, highly accurate chemical analyses.*
