## On-Line Boiler Deslagging Returns Efficiencies and Decreases Outages

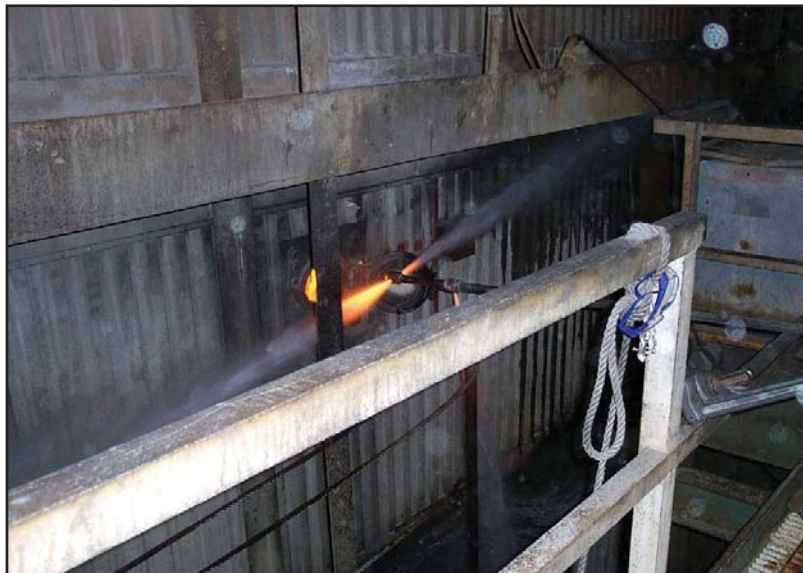
*Skilled technicians guide specially tooling into the boiler port to gain access to the clinker. MPW prides itself on innovative tooling and technology to remedy any customer concern.*

MPW Associates evaluated the problem and discussed several potential cleaning methods with the plant project team. Cleaning on-line was paramount, so MPW utilized high pressure hydroblasting technology to safely remove the slag build-up and reclaim boiler efficiency. The

boiler had four pre-existing ports at different elevations on each sidewall and three observation ports along the front wall of the boiler. Using the existing portholes MPW went to work. A spotter was positioned on the front wall and directed blasting technicians positioned along the sidewalls via radio communications. The blasting technicians inserted their equipment into the ports and worked it across the leading edge of the clinker until it was completely removed. Utilizing MPW's proprietary waterblasting equipment, a 10,000 p.s.i. pump and a six-man crew including four technicians, one operator and one supervisor, MPW completed the job in approximately four shifts.

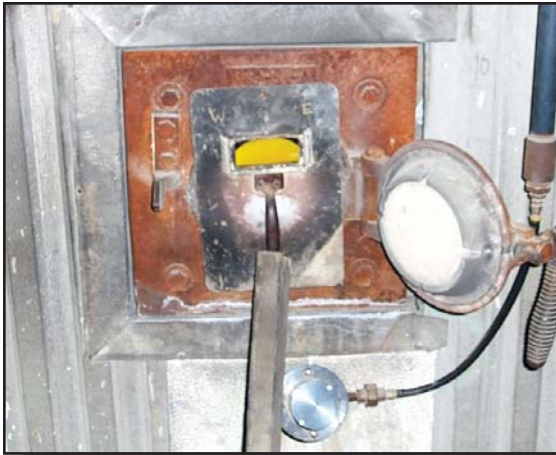
View through access point on the boiler wall. Coal powered boiler temperatures can range from 2200-2500°F, which creates high demands for cleaning equipment.

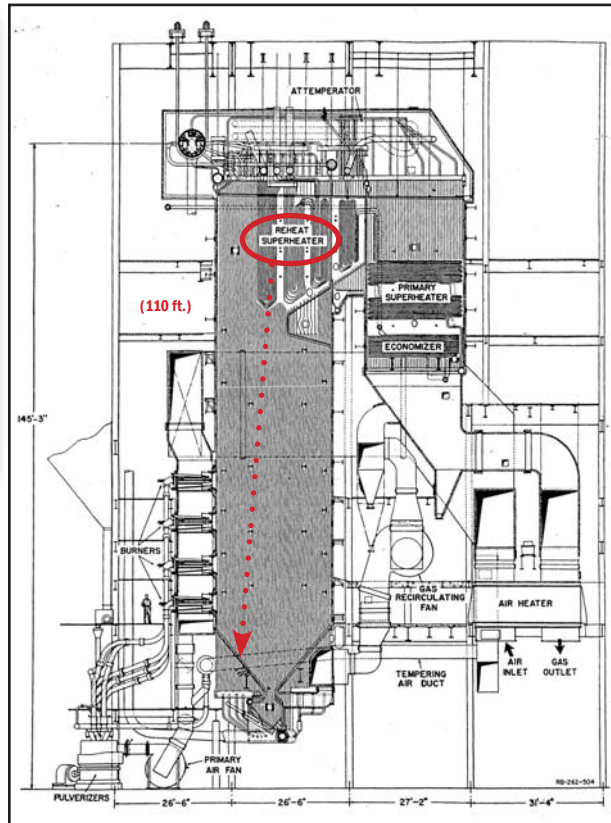
The boiler schematic highlights the clinker's dramatic fall from the superheater down to the lower section of the boiler.

A Northeastern power generation facility developed a large slag deposit (clinker) in their largest unit. The station attempted several different methods to remove the clinker including increased sootblowing, varying load and burning off the clinker. While attempting to bring the unit off-line for deslagging, the clinker fell from the leading edge of the superheater and caused severe damage to the lower furnace slope and sidewalls. The clinker was the size of a small bus and fell approximately 100 feet. The damage required an extended forced outage to return the unit to service, followed by a lengthy overhaul to replace many of the damaged components. Several months later another clinker formed. This time the station tried to use a homemade water lance to remove the clinker but achieved minimal success. The lance was heavy and unwieldy and could not extend far enough into the furnace to reach the problem area. Once again the unit had to be taken off-line for deslagging. It became clear that taking the unit off-line for slag removal was not a cost effective solution. Since newer, cheaper coals were going to be burned for the foreseeable future, a new method of cleaning had to be adopted quickly.
